I have a 2010 Prius IV, VIN JTDKN3DU9A1011549 and at about 40,000 miles the pad on the parking brake arm fell off. I put it back on but it kept falling off. I made sure the square protrusion on the inside-right was pressed into the rectangular hole on the parking brake arm. This design is supposed to keep it in place but it didn't. So, I ordered a new one from our dealership hoping the design would be improved. When it came in I matched it up and it was the same. I didn't see any design changes. The parts clerk told me there was a service bulletin out on this part and that it stated that if it fell off it was to be glued back on. That was an unsatisfactory solution so I asked the clerk to find another part that would work. He found another brake pad that he said should work but didn't state which year or model Prius on which it was to be used. The part number for the second pad he ordered is 46252-47010, Pad, Parking Brake.

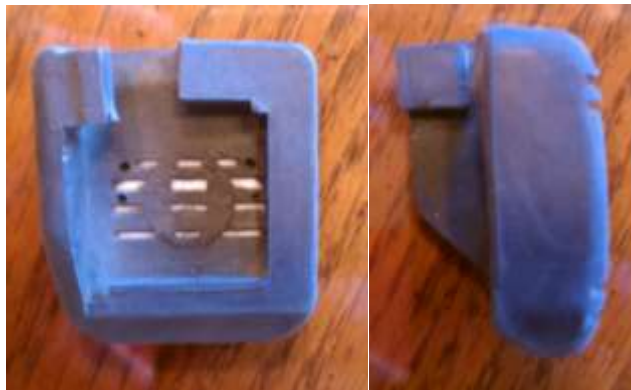
The following two images are of the original parking brake pad for a 2010 Prius IV.

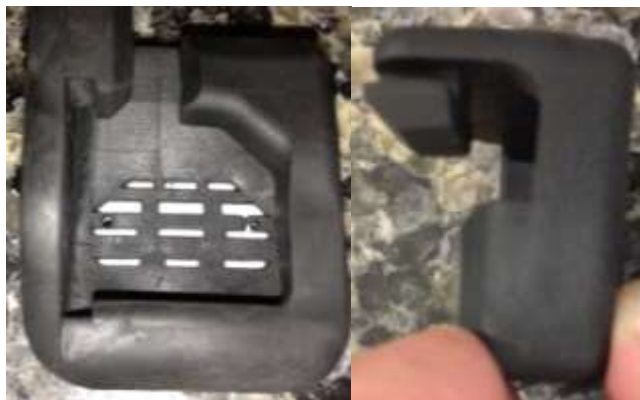
When the pad arrived I compared it to the pad that was on my car when it was manufactured. The replacement pad was designed slightly different in two ways. First, the piece that inserts into the side of the parking brake arm was rectangular in shape, providing about 1/8" overlap on the inside top of the brake arm. Second, on the back one of the corners has a triangular flap of rubber that makes it more difficult for it to fall off. The attached document shows both the original and the pad I used to replace it.

The next two images are of the one I used to replace the original part. Note the differences.

Although this is not the correct part for my car, per the online parts catalog, I believe it is better than the one that was on it when manufactured. It is not necessary to use glue on it to keep it in place.

The reason I decided to post my experience is that I believe Toyota should have issued a service bulletin that calls for the original part to be replaced by the part 46252-47010, not to glue the same type off pad in place. The old pad could be easily replaced by the new pad during an oil change, or other scheduled service.
